Test Report

No.: CANEC23016990209

Sample Name: ASSEMBLY LED

Model No.: XL-DZ304SYGD/4

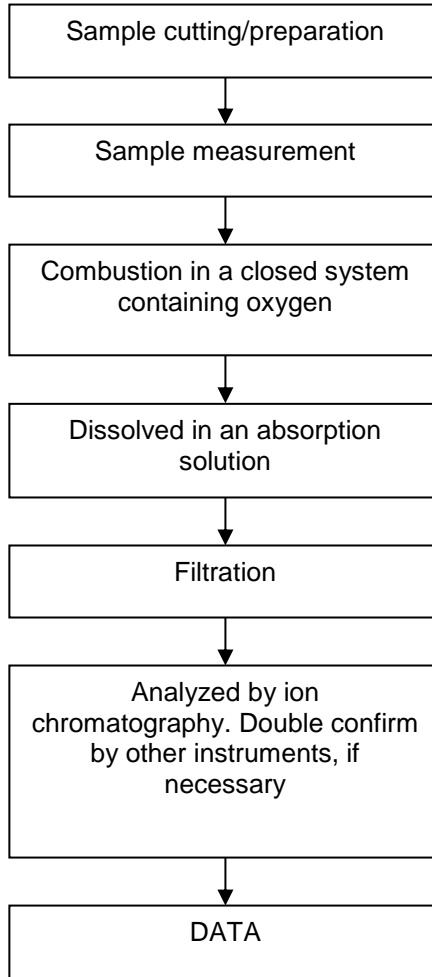
Halogen Testing Flow Chart

Test Method: With reference to EN 14582:2016, analysis was performed by IC.

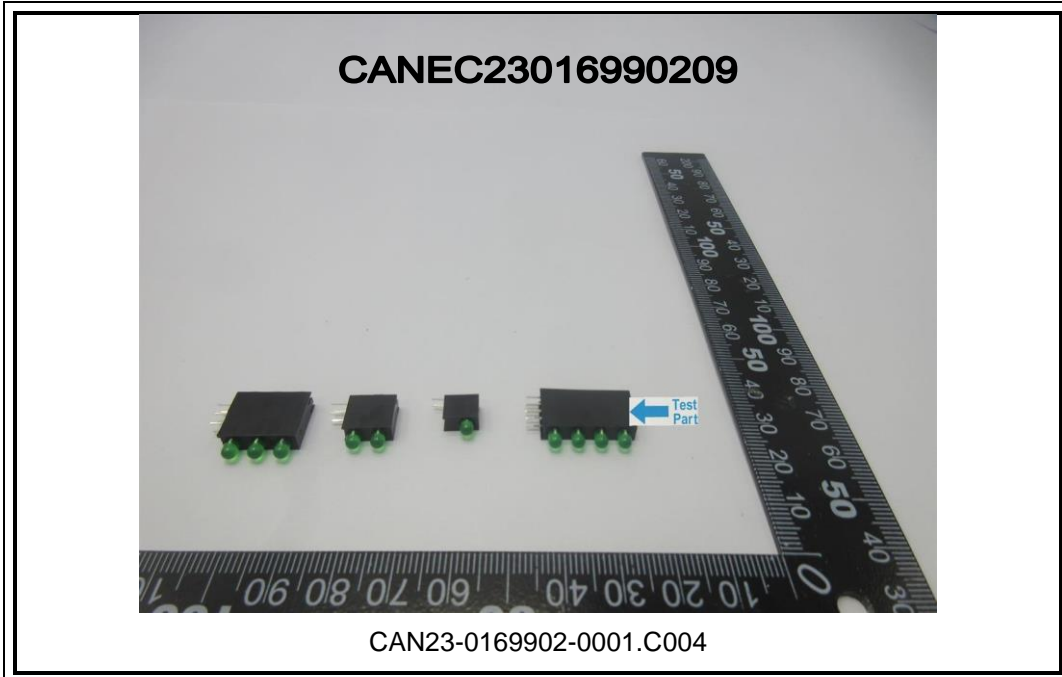
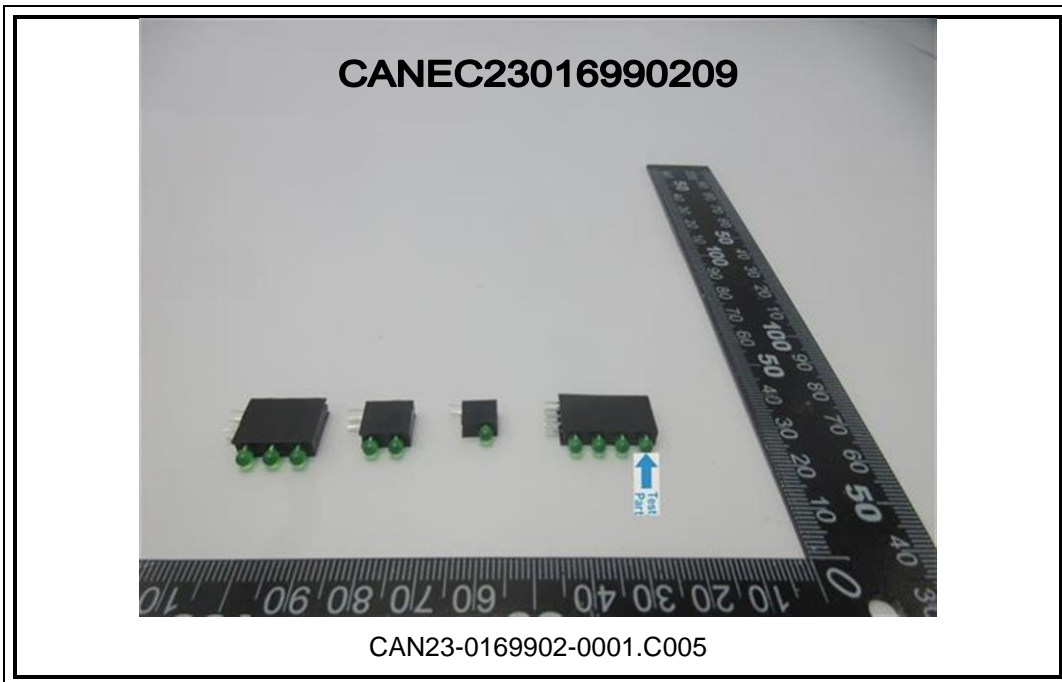
Sample Photo:

SN ID	Sample No.	SGS Sample ID	Description
SN1	A4	CAN23-0169902-0001.C004	Black plastic
SN2	A5	CAN23-0169902-0001.C005	Green plastic
