## Test Report

No.: CANEC26005422747\_1

Sample Name: XL- ITR

Client Ref. Information: Through-beam photoelectric sensor, Reflective photoelectric sensor

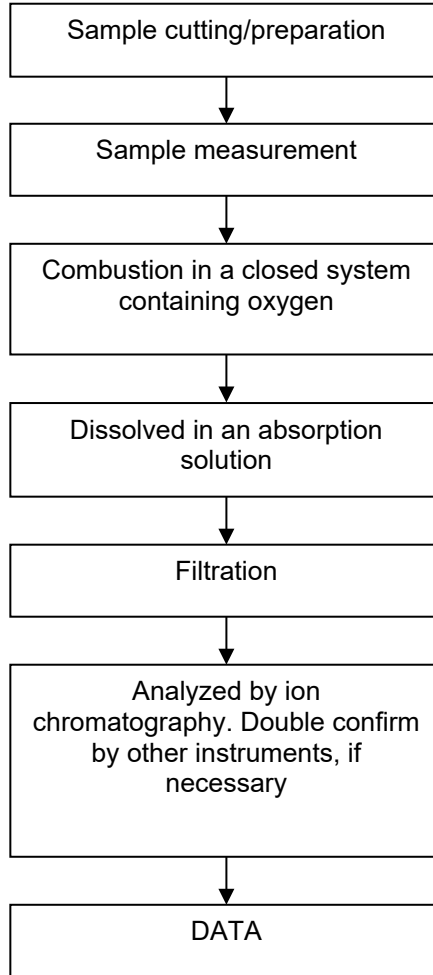
### Halogen Testing Flow Chart

**Test Method:** With reference to EN 14582:2016, analysis was performed by IC.

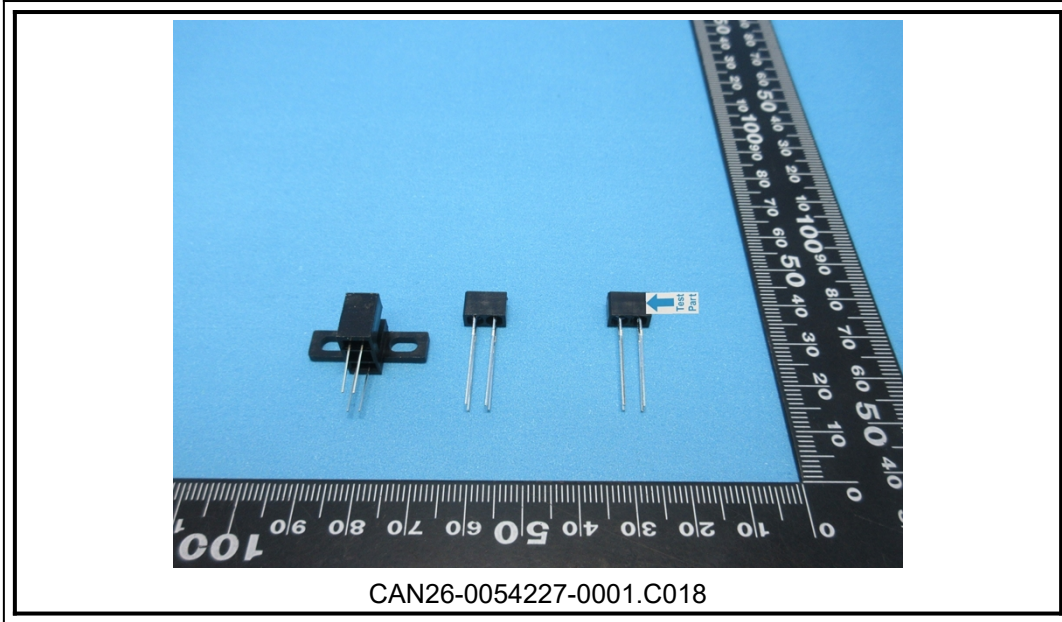
### Sample Photo:

SN ID	Sample No.	SGS Sample ID	Description
SN1	A18	CAN26-0054227-0001.C018	Black plastic
