Test Report

No.: CANEC26005422721

Sample Name: Infrared Receiver Header

Model No.: XL-IRM

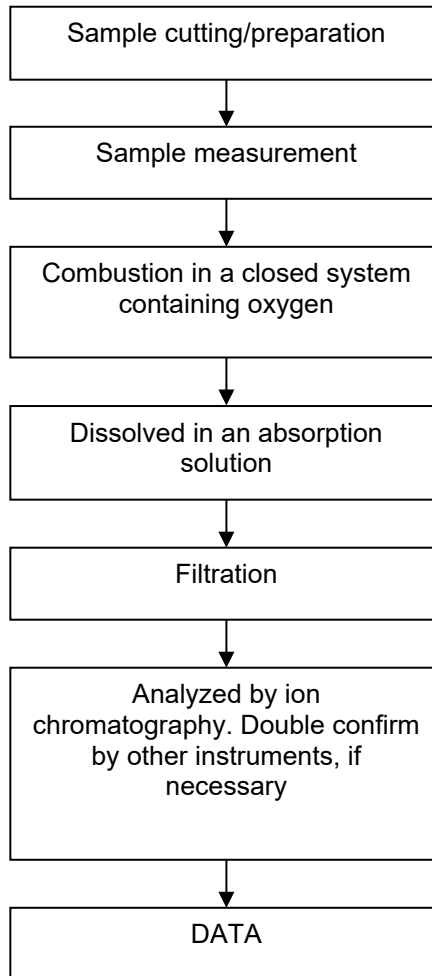
Halogen Testing Flow Chart

Test Method: With reference to EN 14582:2016, analysis was performed by IC.

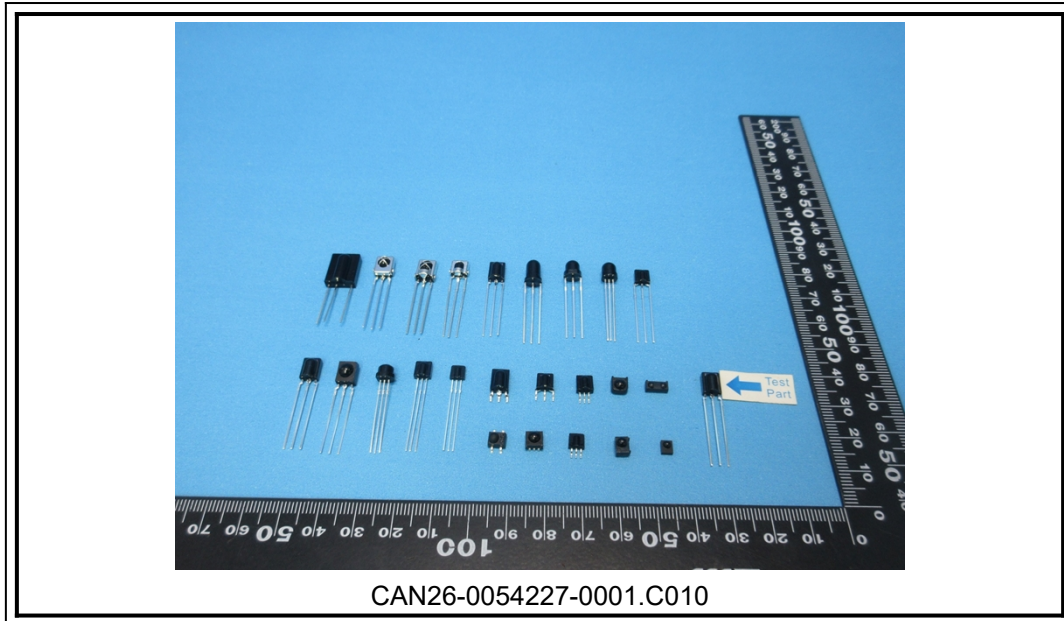
Sample Photo:

SN ID	Sample No.	SGS Sample ID	Description
SN1	A10	CAN26-0054227-0001.C010	Black plastic
